# ROOF INSPECTION REPORT

Date of Inspection: 14 June 2026  
Date of Report Submission: 22 June 2026  
Report No: 26-004-R01-A  
Job No: 26-004

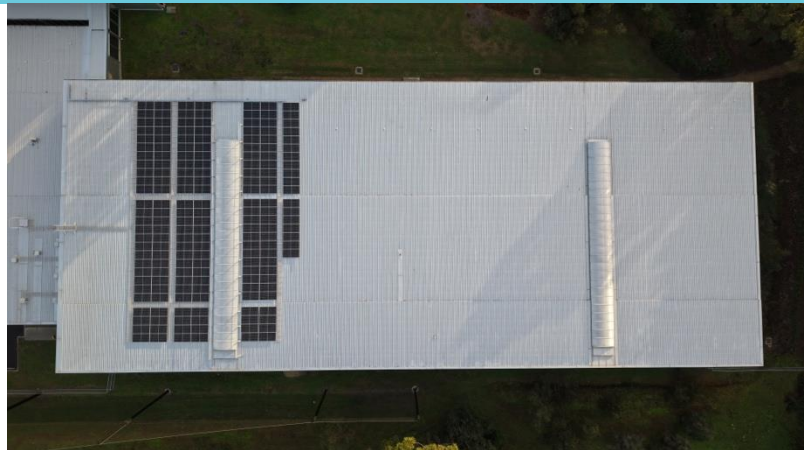
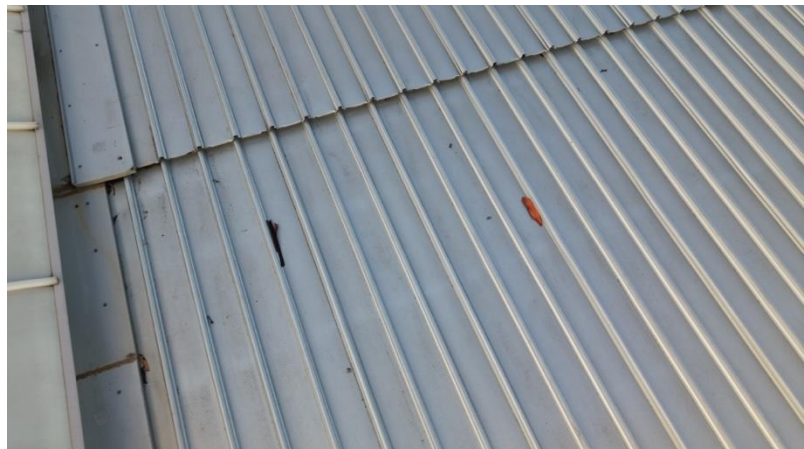
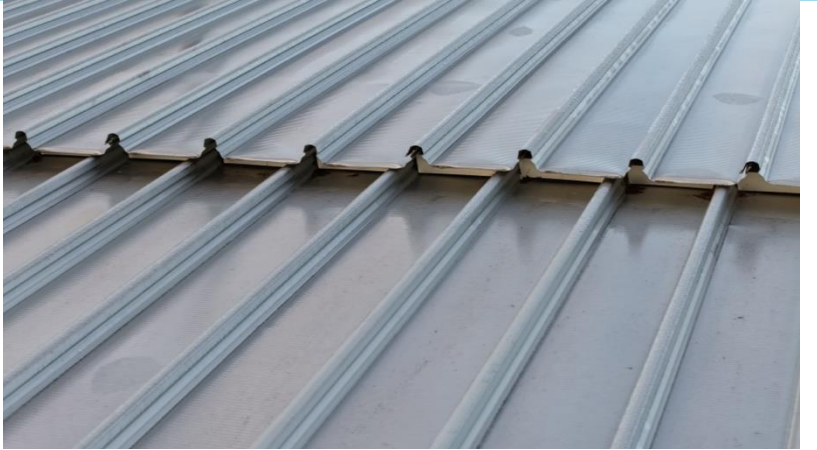
| No. | Item | Description/Issue/Defect | Suggested Remediation | Photograph(s) |
|---|---|---|---|---|
| 1 | Roof sheeting | <p>Roof sheeting comprises of Zinalume Klip-Lok 700 Hi-Strength, installed at what appears to be adequate pitch.</p> <p>Roof sheeting is in generally good condition, indicative of relatively recently installed roof sheets.</p> <p>There is a small amount of debris on some parts of the roof.</p> <p>See section 4. Findings Summary: Cleaning.</p> | <p>Generally no action required</p> <p>Clean roof sheets and remove debris.</p> | |

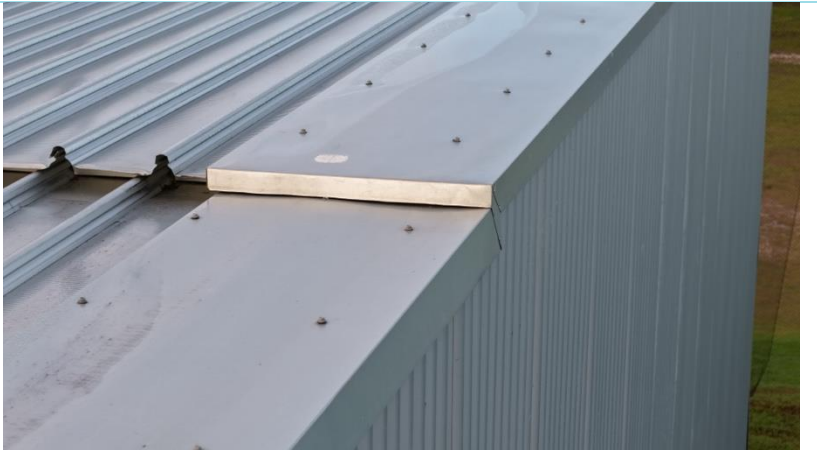
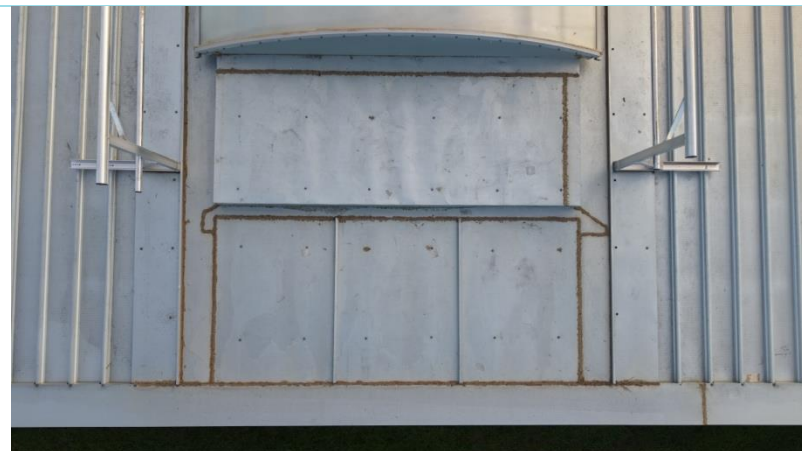
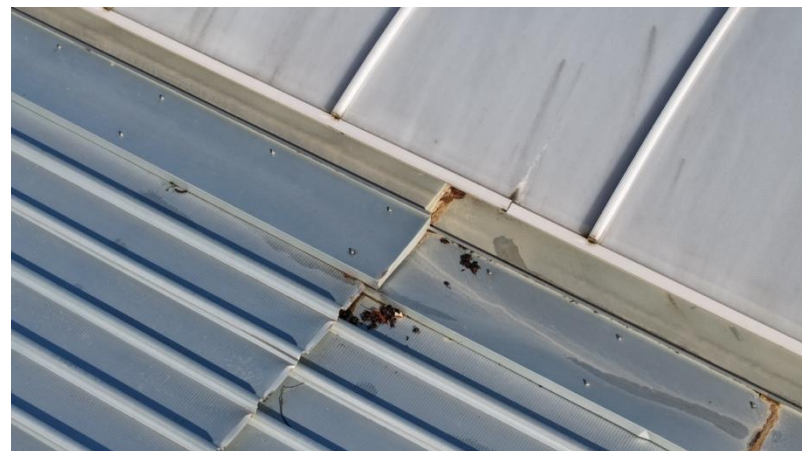
| 2 | <b>Flashings and Expansion Joints</b> | <p>Flashings across the roof are generally in excellent condition and exhibit good workmanship.</p> <p>Fixings and sealing are generally adequate.</p> <p>As previously stated some areas have accumulated debris.</p> | <p>No action required generally</p> <p>Clean flashings and remove debris</p> | |

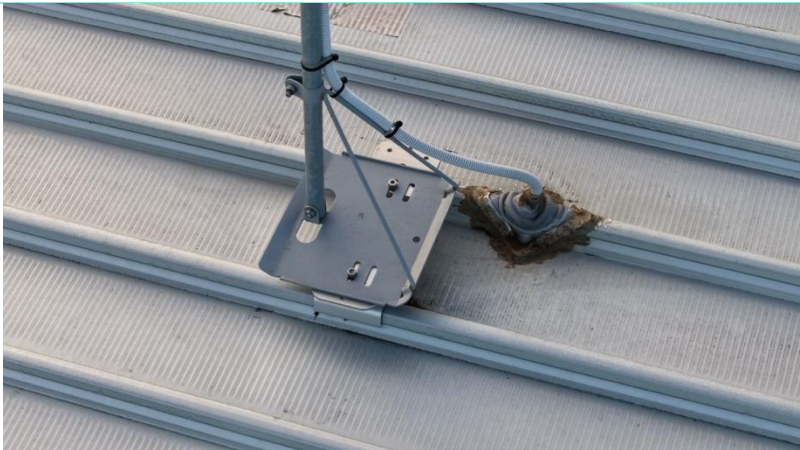
| 3 | <b>Dektite</b> | <p>A penetration and associated Dektite have been installed to the rib of the roof sheets.</p> <p>While not inherently problematic, this creates a structural weak point in the roof sheet rib. Care should be taken during roof access to ensure that this area is not stepped on.</p> <p>Should leaking occur in the future in the vicinity of this Dektite, checking for damage here would be prudent.</p> | <p>No immediate action required. Monitor for leaking in the vicinity of this penetration. If leaking occurs, inspect the Dektite, sealant and surrounding roof sheet rib for damage or displacement.</p> | |

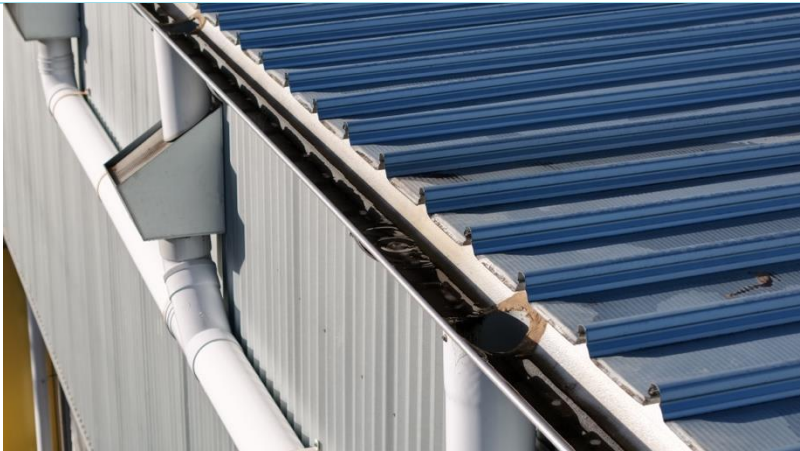
| 4 | <b>Eaves Gutters</b> | <p>Eaves gutters appear to be installed in an appropriate and tradesmanlike manner. However, some sections of the eaves gutters appear to be ponding water. Refer to Appendix B for a video showing the extent of this problem.</p> | <p>Clean gutters and remove any debris or sediment that may be contributing to water retention. Following cleaning, inspect gutter fall toward downpipes. If ponding persists after cleaning, re-pitch affected gutter sections to achieve adequate drainage gradient.</p> | |

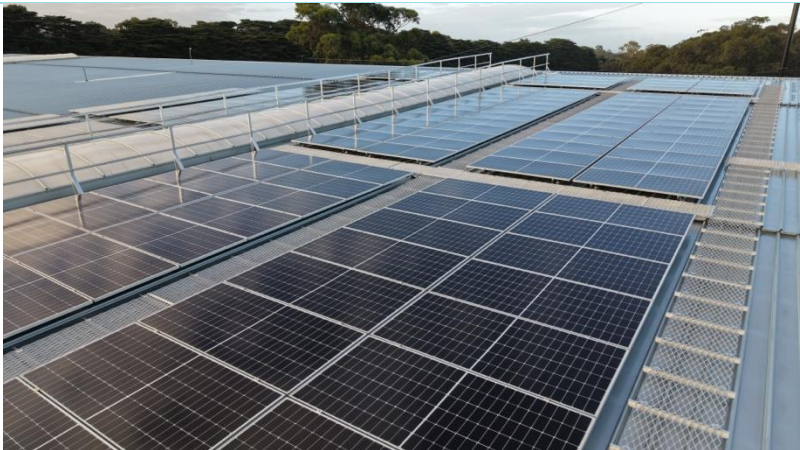
| 5 | <b>Solar Installation</b> | Solar installation and associated roof penetrations/fixings appear to have been installed in a tradesmanlike manner. | No action required | |

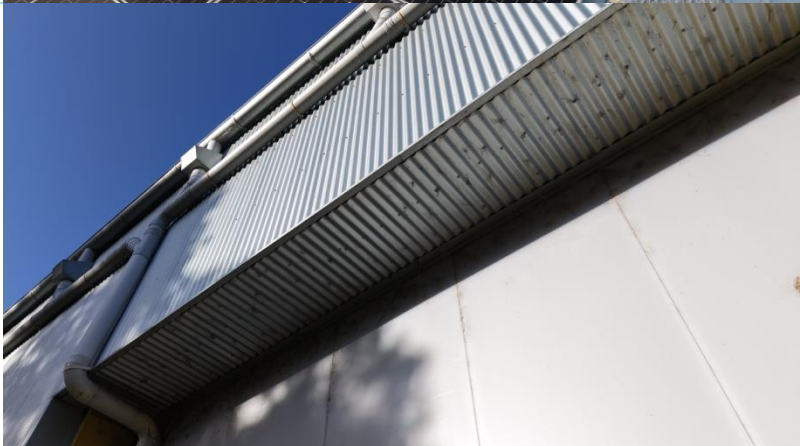
| 6 | <b>Soffits and Cladding</b> | Soffit and wall sheeting is Zinalume Corrugated Iron and appears to be in serviceable condition. Some biological growth and dirt accumulation is evident on the soffit underside. | <p>Biological growth needs to be cleaned to prevent accumulation of dust and moisture.</p> <p>Regular washing of all soffits is highly recommended to extend the service life of the material.</p> | |

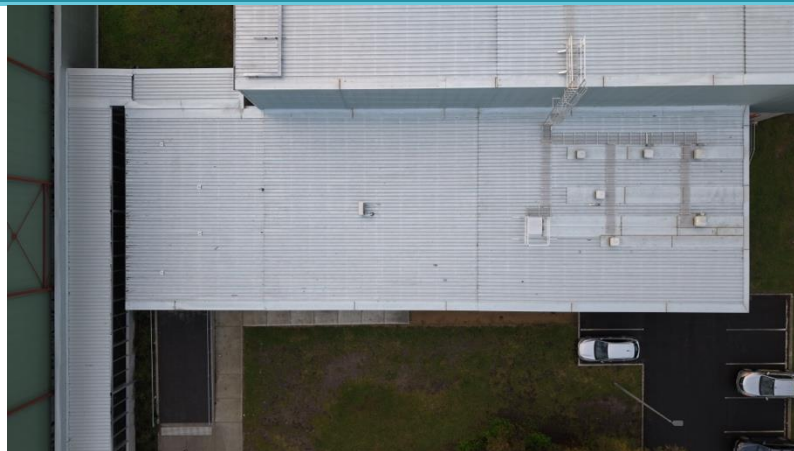
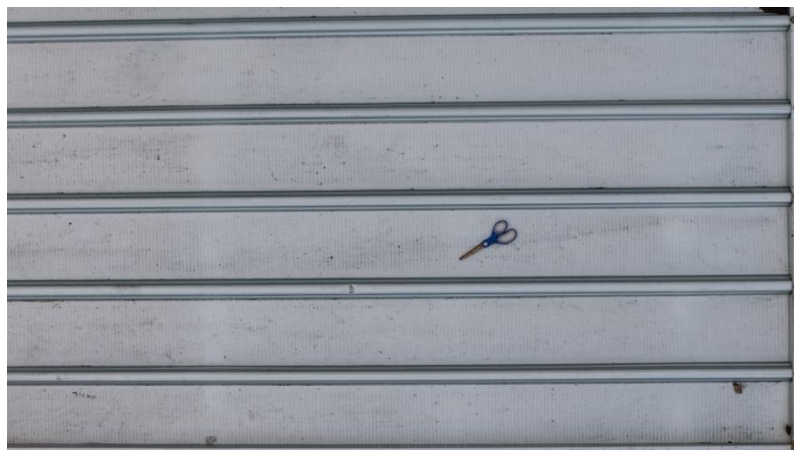
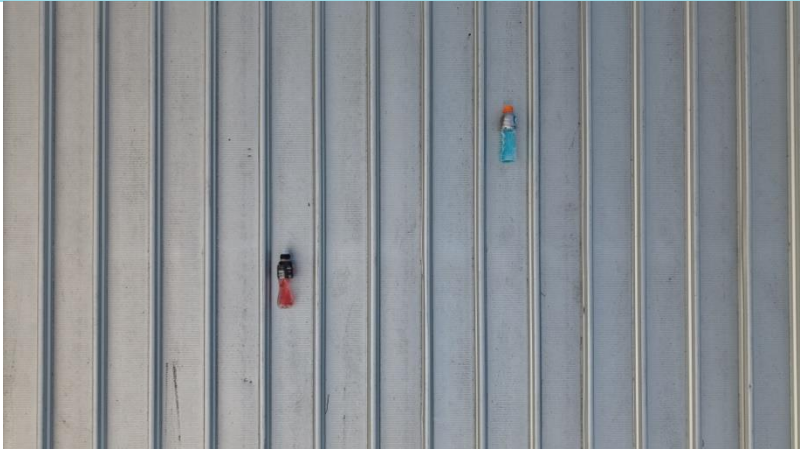
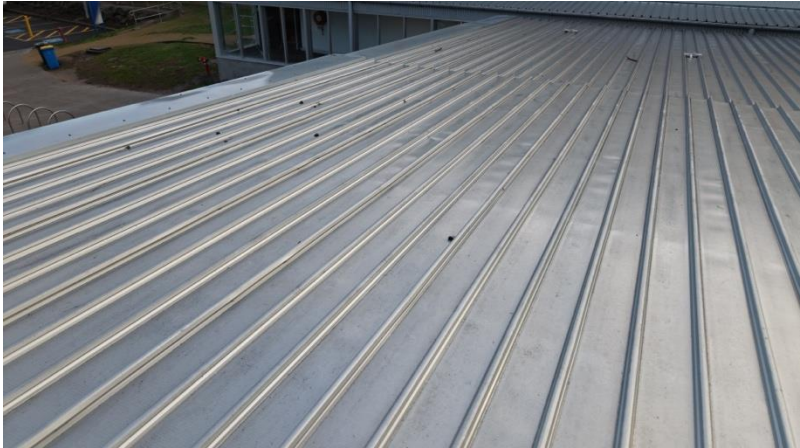
| No. | Item | Description/Issue/Defect | Suggested Remediation | Photograph(s) |
|---|---|---|---|---|
| 1 | Roof sheeting | <p>Roof sheeting comprises of Zinalume Klip-Lok 700 Hi-Strength, installed at what appears to be adequate pitch.</p> <p>Roof sheeting is in generally good condition, indicative of relatively recently installed roof sheets.</p> <p>There is a small amount of debris on some parts of the roof.</p> <p>See section 4. Findings Summary: Cleaning.</p> | <p>Generally no action required</p> <p>Clean roof sheets and remove debris.</p> | |

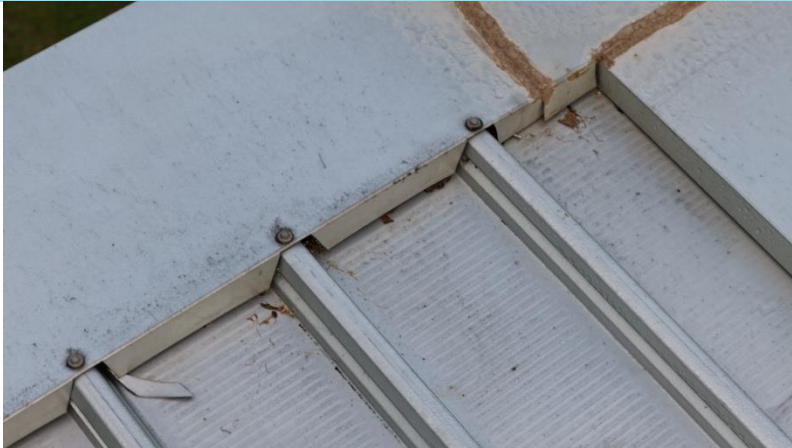
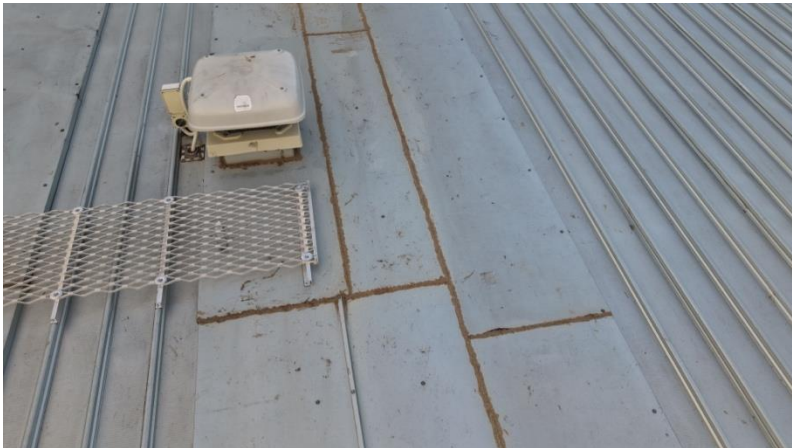
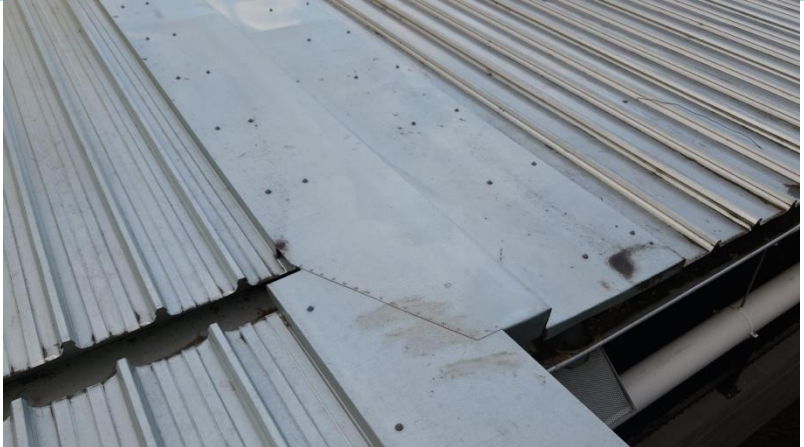
| 2 | <b>Flashings</b> | <p>Flashings have been installed in a generally tradesmanlike manner and are in good visual condition.</p> <p>Apron flashings were observed to be of average scribing quality; however, this is a cosmetic observation only and is not considered likely to affect the weathering performance or service life of the flashing installation.</p> | Generally no action required | |

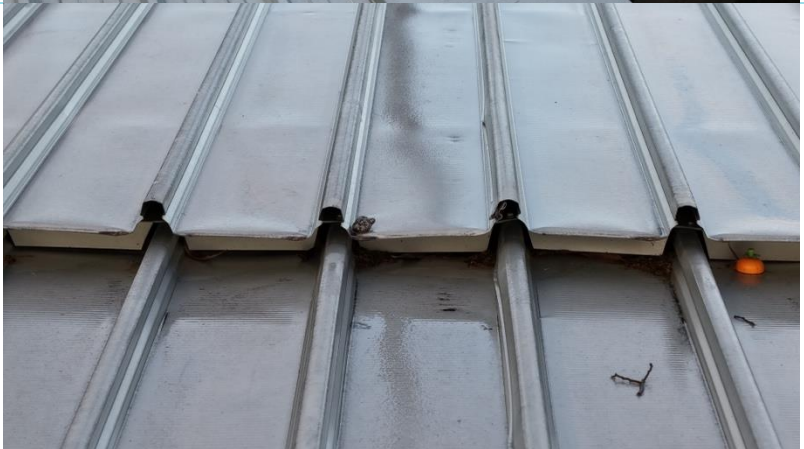
| 3 | Expansion Joints | Expansion joints have been installed in a tradesmanlike manner and appear to be in good visual condition. | No action required | |

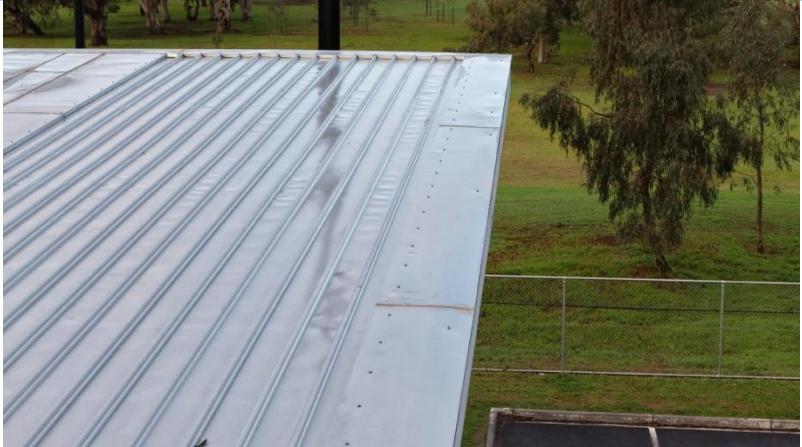
- Barge cappings on Roof 2 were found to have inadequate fixing density at the outer edge, which is the surface most subject to wind uplift and negative pressure loading. This presents a risk of capping displacement or detachment under high wind conditions and should be addressed in a timely manner.

| 4 | <b>Barge Cappings</b> | <p>Barge cappings are in good visual condition and appear adequately sealed.</p> <p>Rivets could not be visually identified on some joints, though it is possible these are concealed beneath applied silicone and a closer physical inspection may be required to confirm</p> <p>Undersealing is not visually apparent</p> <p>Fixing frequency to the outer edge, which is the surface most subject to wind uplift and negative pressure loading, appears to be inadequate.</p> | <p>Physically inspect joints to confirm adequate riveting</p> <p>Physically inspect joints to confirm undersealing present</p> <p>Install additional fixings to outer edge of barge cappings</p> | |

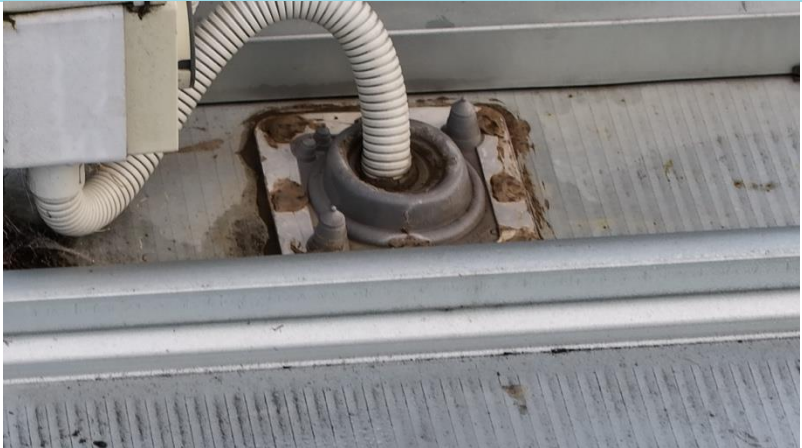
- The Dektite boot observed on Roof 2 was noted to be concaving inward, forming a bowl-like depression conducive to water pooling. The absence of standing water in this depression following recent rainfall suggests that the seal may already be compromised and water may be tracking into the roof cavity. Physical inspection of this penetration is recommended as a priority.

| 5 | <b>Dektite</b> | <p>A Dektite boot was observed to be concaving inward, creating a bowl-like depression around the penetration that is conducive to water pooling. Despite recent rainfall at the time of inspection, no water was present in this depression, suggesting the seal may already be compromised and water is tracking into the roof cavity.</p> | <p>Physically inspect the Dektite boot and associated silicone sealing for evidence of breach or deterioration. If compromised, remove and replace the boot and reseal all penetration edges. Rectify the concaving profile to prevent ongoing water pooling at this location.</p> | |

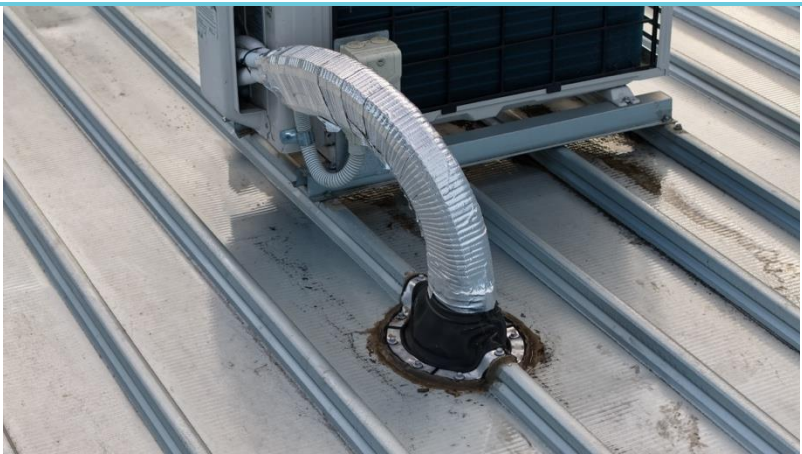
| 6 | <b>Dektite</b> | <p>A penetration and associated Dektite have been installed to the rib of the roof sheets.</p> <p>While not inherently problematic, this creates a structural weak point in the roof sheet rib. Care should be taken during roof access to ensure that this area is not stepped on.</p> <p>Should leaking occur in the future in the vicinity of this Dektite, checking for damage here would be prudent.</p> | <p>No immediate action required. Monitor for leaking in the vicinity of this penetration. If leaking occurs, inspect the Dektite, sealant and surrounding roof sheet rib for damage or displacement.</p> | |

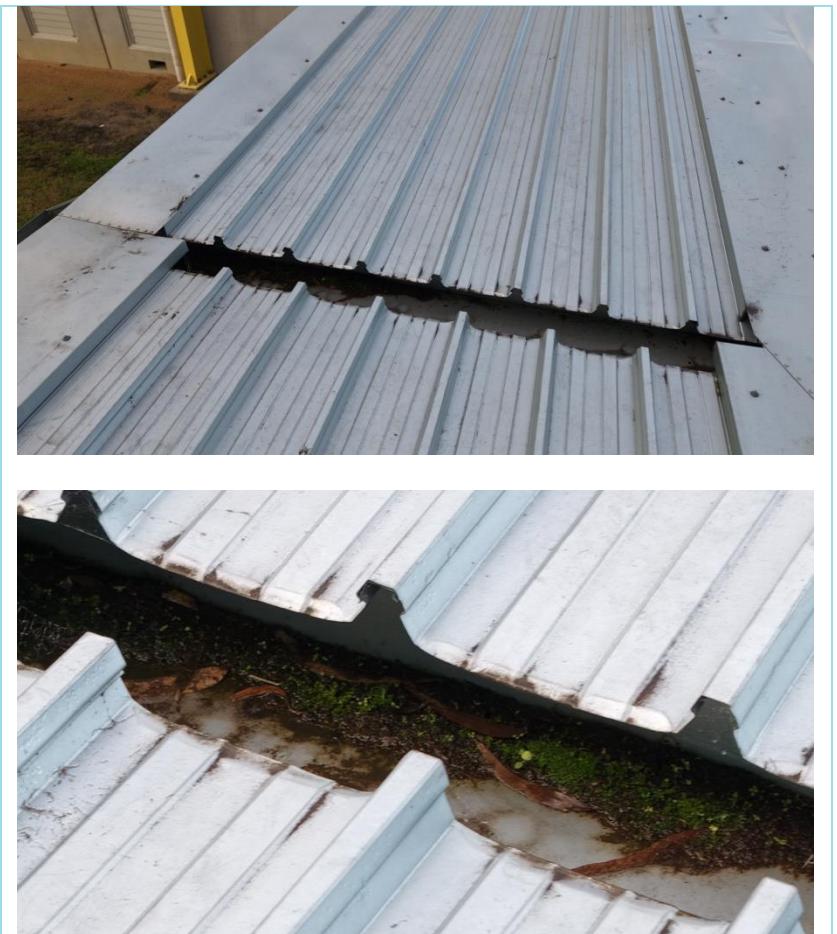
| 7 | <b>Box Gutter</b> | <p>The box gutter was observed to have accumulated tree bark and leaf litter and is growing moss.</p> <p>See section 4. Findings Summary: Cleaning.</p> | <p>Clean the box gutter and remove all debris and moss growth</p> | |

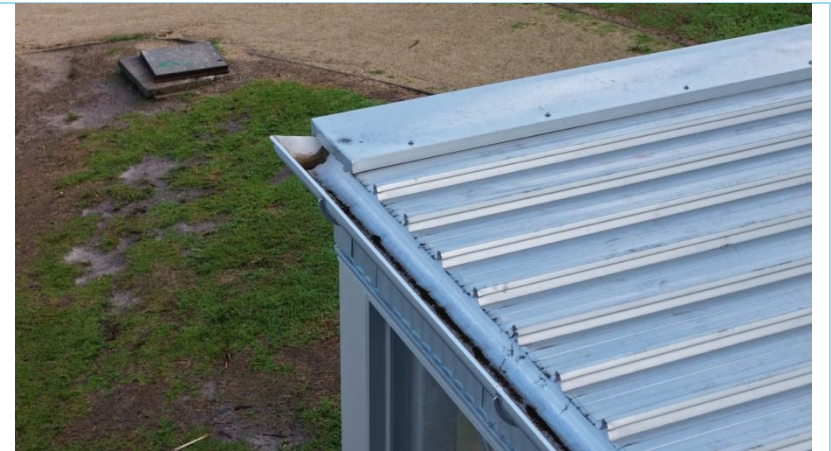
| 8 | <b>Eaves Gutter</b> | The eaves gutter appears to be in good condition with only a minor amount of sediment present at the base. No significant debris accumulation or evidence of ponding was observed. | No immediate action required |

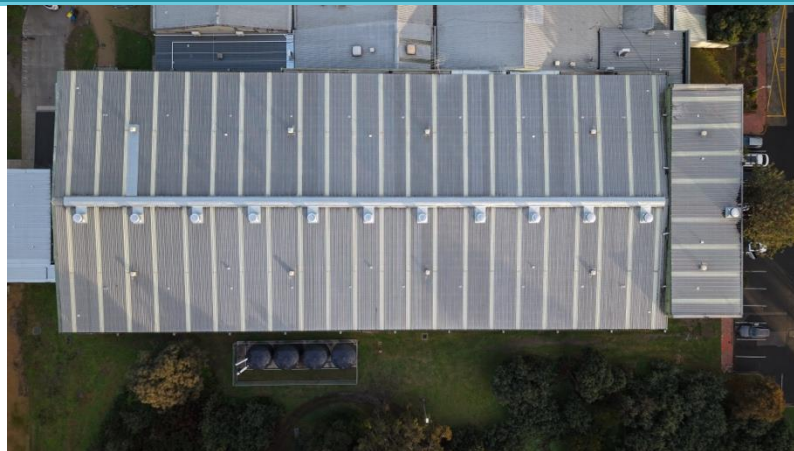
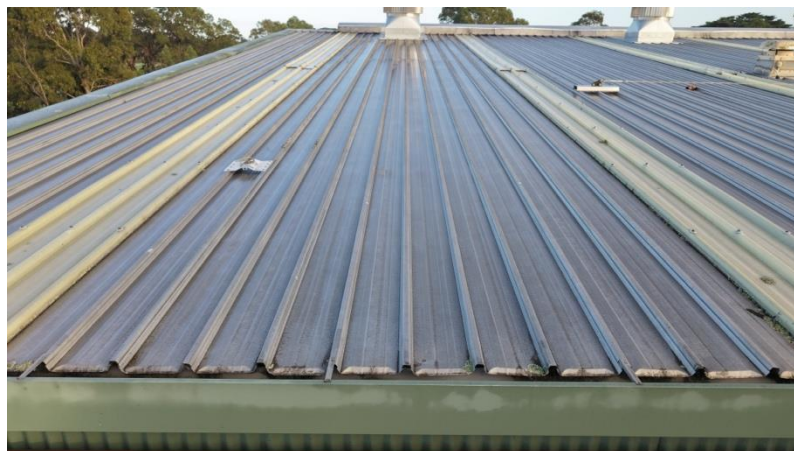
| No. | Item | Description/Issue/Defect | Suggested Remediation | Photograph(s) |
|---|---|---|---|---|
| 1 | Roof sheeting | <p>Roof sheeting is of Klip-Lok Classic profile, installed at what appears to be adequate pitch. The sheet material could not be confirmed with certainty from the drone inspection, as surface debris and weathering obscure the substrate. The sheeting is consistent in appearance with either galvanised steel or Zincalume; inspection of cleaned roof sheets at close range would be required to confirm the material with confidence.</p> <p>Roof sheeting is in generally good condition consistent with its age. Lichen growth was observed across many parts of the roof sheeting surface. While lichen does not cause immediate structural concern, it retains moisture against the sheet surface and will accelerate coating degradation and corrosion if left untreated.</p> | <p>Generally no action required</p> <p>Clean roof sheets and remove debris.</p> | |

Fibreglass sheeting is in good condition and appears to be of a significantly more recent installation than the surrounding roof sheeting.

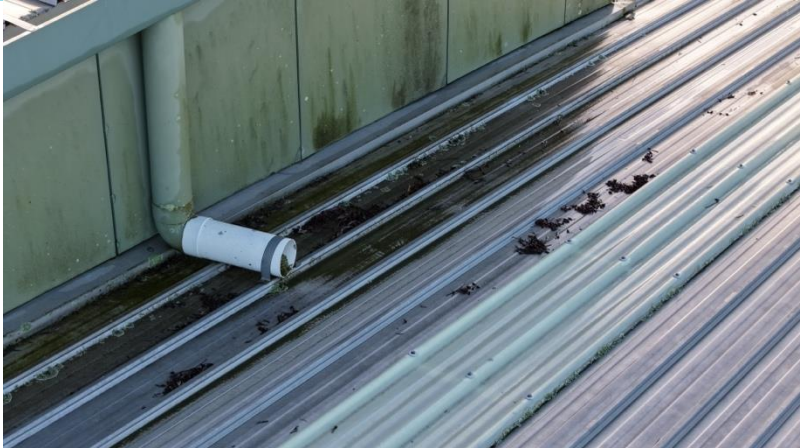
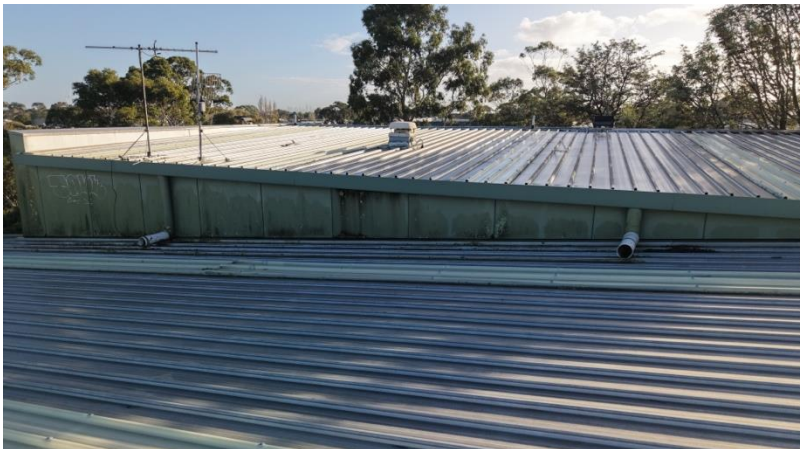
| 5 | <b>Downpipe Spreaders</b> | <p>Downpipe spreaders directing runoff from Roof 4 were observed to be discharging into pans containing a significant accumulation of debris and sediment. Accumulated organic matter and sediment retains moisture against the pan surface, accelerating corrosion of the substrate and reducing the serviceable life of the pans.</p> <p>See section 4. Findings Summary: <b>Cleaning.</b></p> | <p>Clean all pans receiving discharge from Roof 4 downpipe spreaders and remove all accumulated debris and sediment. Regular scheduled cleaning is recommended to minimise ongoing corrosion risk.</p> | |

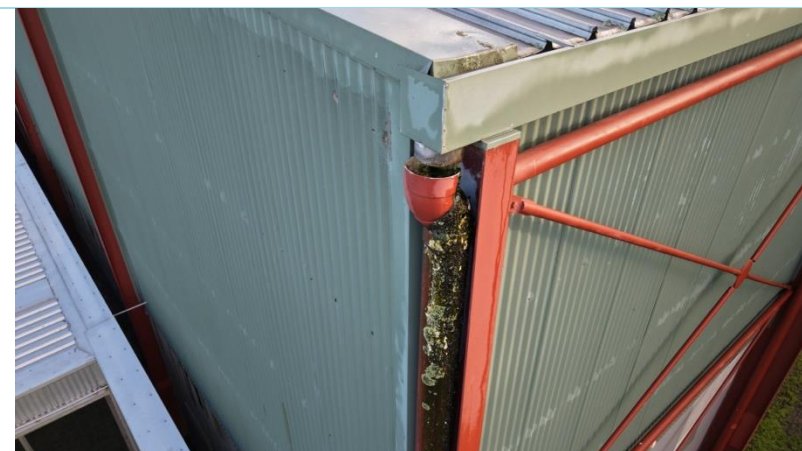
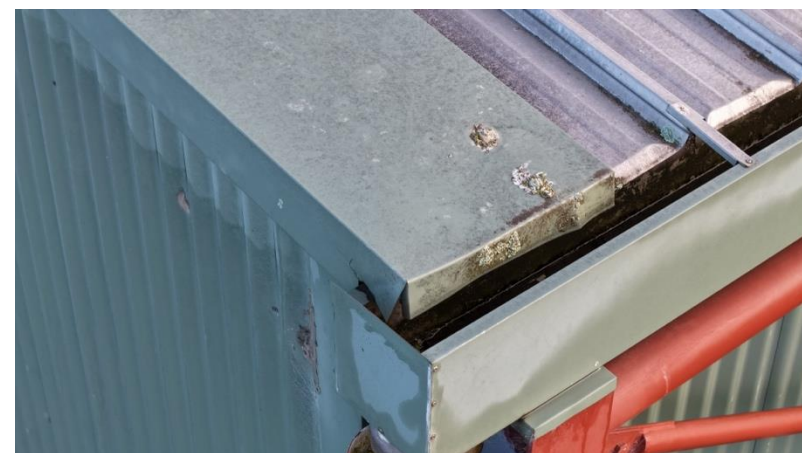
- At least one downpipe on Roof 3 was observed to be disconnected from its gutter outlet. This results in uncontrolled discharge of rainwater at that location and should be rectified promptly to prevent water damage to the building fabric below.

| 6 | <b>Eaves Gutters and Downpipes</b> | <p>Eaves gutters are Colorbond and were observed to be ponding water, with moss growth present along their length. Significant lichen growth was observed on the exterior of the downpipes. At least one downpipe was observed to be disconnected from its gutter outlet, which will result in uncontrolled discharge of rainwater at that location.</p> | <p>Clean gutters and remove all moss growth and debris. Inspect gutter fall toward downpipes and re-pitch affected sections if ponding persists following cleaning.</p> <p>Reattach the dislodged downpipe to the gutter outlet and secure appropriately.</p> <p>Clean lichen growth from the exterior of all downpipes. Regular scheduled cleaning is recommended to prevent recurrence.</p> |

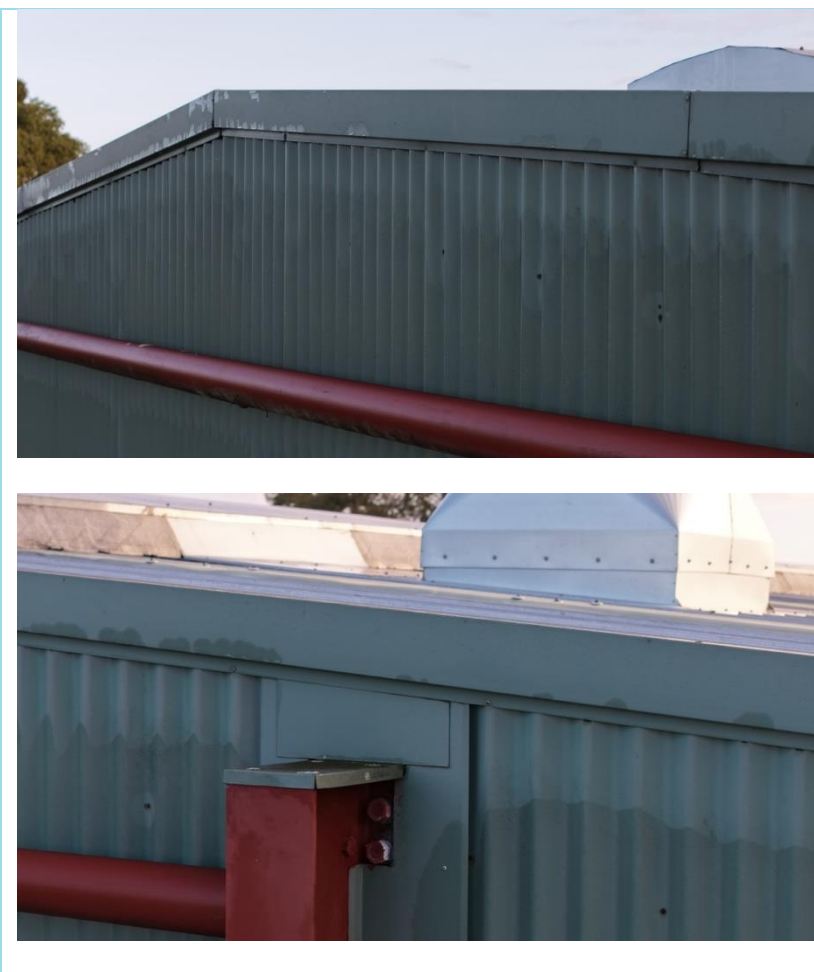
| 7 | <b>Barge Cappings</b> | <p>Barge cappings appear to be in reasonable condition for their age. Undersealing could not be confirmed from the drone inspection undertaken.</p> <p>Areas of abrasive wear were observed where the Colorbond coating has been worn through, exposing the underlying sheet substrate to the elements.</p> | <p>Undertake a physical inspection to confirm the presence and adequacy of undersealing and make good any areas where it is found to be absent or insufficient.</p> <p>Treat all areas of exposed substrate with an appropriate corrosion inhibiting primer and compatible touch-up coating to restore surface protection.</p> | |

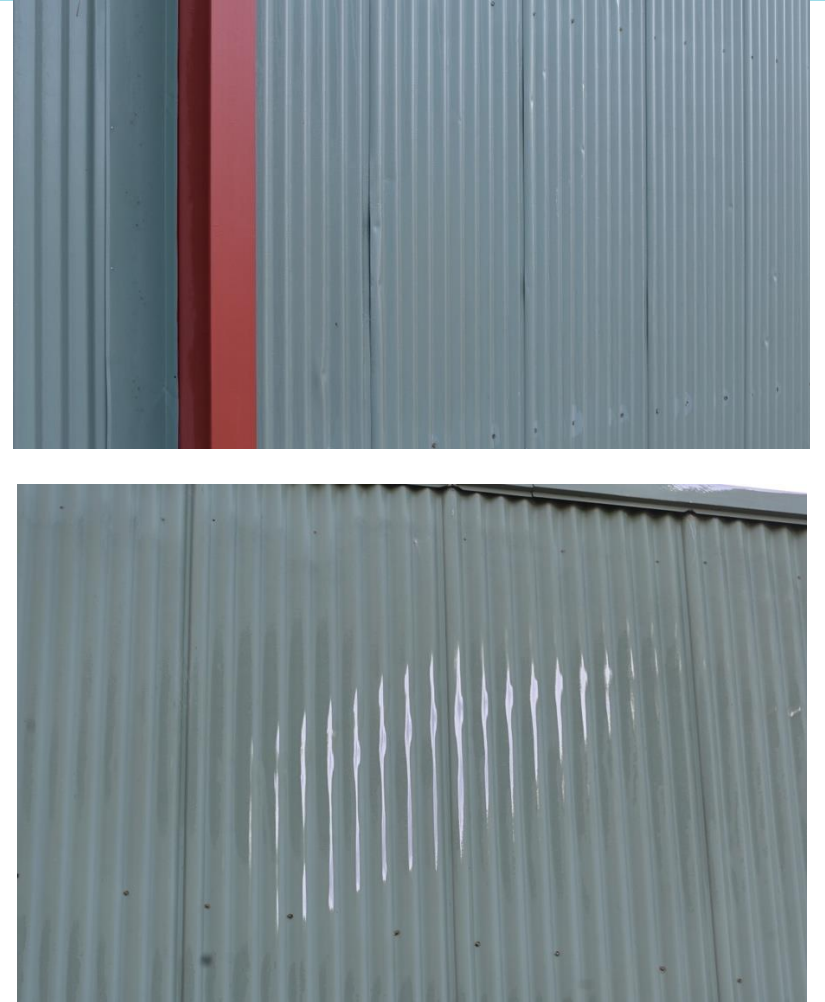
| 8 | <b>Wall Cladding</b> | <p>Wall cladding comprises Colorbond Corrugated Iron. Some physical damage was observed, including visible denting and sheet deformation at various locations. Of particular concern are areas where abrasive action has worn through the Colorbond coating, exposing the underlying sheet substrate to the elements. Unprotected substrate is susceptible to accelerated corrosion and should be treated promptly.</p> | <p>Treat all areas of exposed substrate with an appropriate corrosion inhibiting primer and compatible touch-up coating to restore surface protection.</p> | |

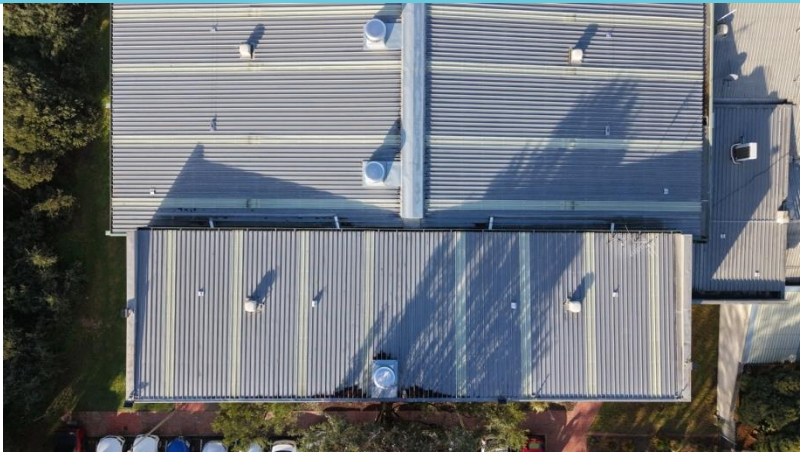
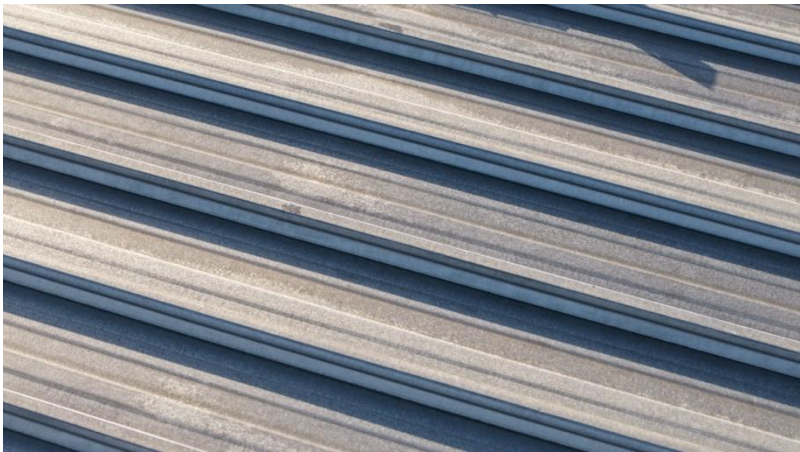
| No. | Item | Description/Issue/Defect | Suggested Remediation | Photograph(s) |
|---|---|---|---|---|
| 1 | Roof sheeting | <p>Roof sheeting is of Klip-Lok Classic profile, installed at what appears to be adequate pitch. The sheet material could not be confirmed with certainty from the drone inspection, as surface debris and weathering obscure the substrate. The sheeting is consistent in appearance with either galvanised steel or Zincalume; inspection of cleaned roof sheets at close range would be required to confirm the material with confidence.</p> <p>Roof sheeting is in generally good condition consistent with its age. Some lichen growth was observed on the roof sheeting surface. A significant accumulation of plant debris was observed across the northern edge of the roof surface, which presents an ongoing corrosion risk if not addressed.</p> <p>Fibreglass sheeting is in good condition and appears to be of a significantly more recent installation than the surrounding roof sheeting, suggesting these</p> | <p>Generally no action required</p> <p>Clean roof sheets and remove debris. Inspect underside of capping to check for further accumulation of debris and clean if required.</p> | |

sheets have been replaced at some point during the life of the roof.

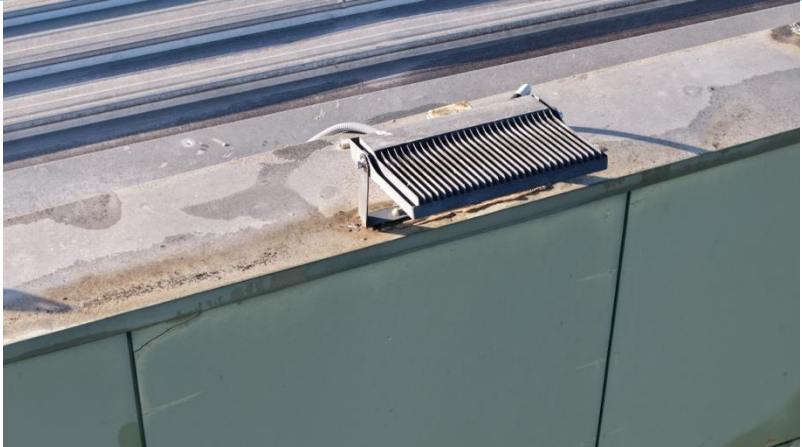
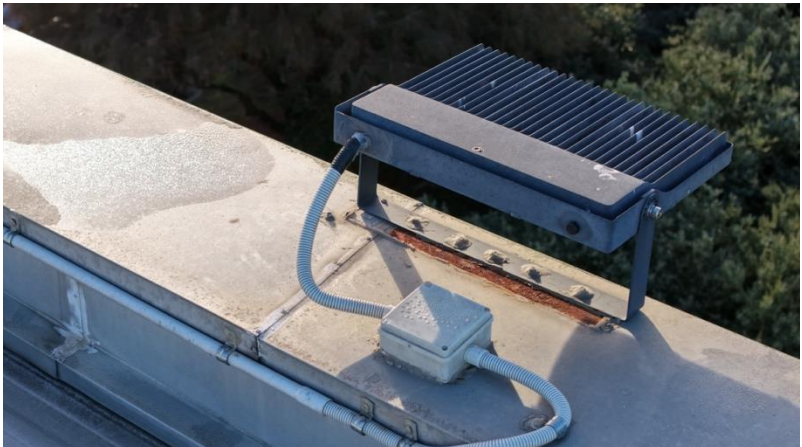
| 2 | <b>Barge Cappings</b> | <p>Barge cappings are in generally good condition and have been installed in a tradesmanlike manner. However, penetrations are present at several locations along the cappings.</p> <p>It appears that some of these penetrations were created by fixings of a dissimilar metal which have since been removed or displaced, exposing the now corroded substrate at the point of contact to the elements. Where the Colorbond coating has been breached in this manner, the underlying substrate is susceptible to ongoing and accelerated corrosion.</p> <p>Some barge cappings were observed to be retaining water along the fixing line, indicating insufficient cross-fall in the capping profile to shed water adequately.</p> | <p>Treat all areas of exposed substrate at penetration points with an appropriate corrosion inhibiting primer and compatible touch-up coating to restore surface protection.</p> <p>Where corrosion is found to be advanced, consider replacement of affected capping sections. Ensure any future fixings to barge cappings are of a compatible material to prevent recurrence of galvanic corrosion.</p> <p>Inspect affected barge cappings and re-pitch or replace sections where ponding is occurring to ensure adequate water shedding away from the fixing line. All fixing penetrations in these areas should be</p> | |

resealed as part of this work.

All fixings and sealant need to be physically inspected and possibly renewed to extend service life of cappings.

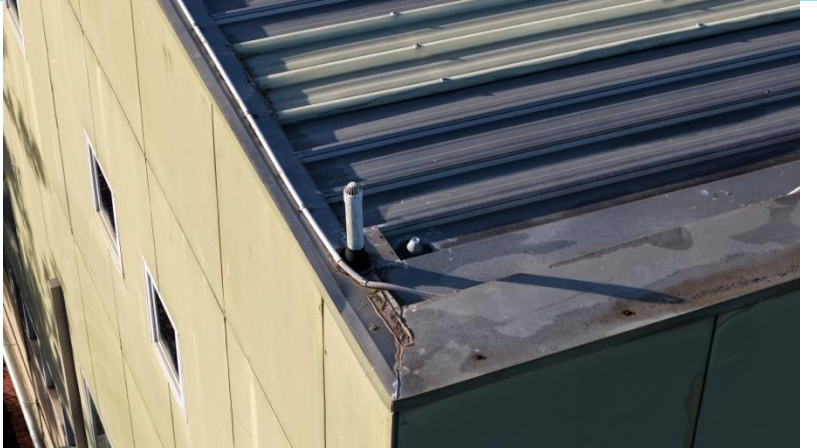
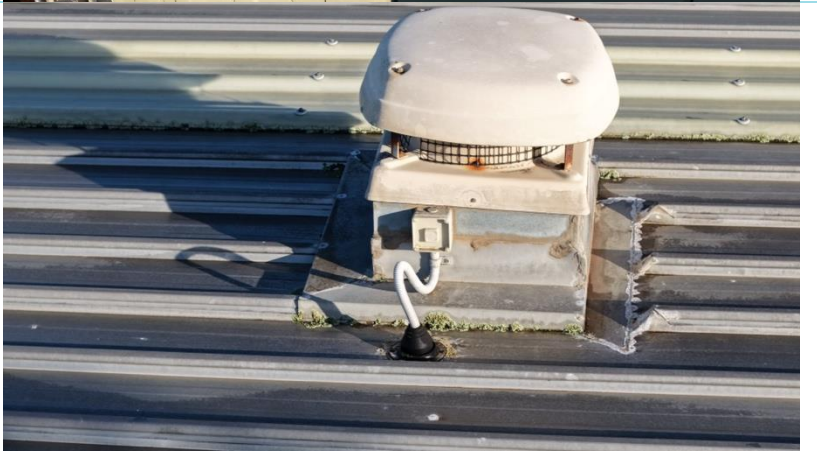
| 3 | <b>Penetrations</b> | <p>Penetration flashings to the electric fans are of a soaker flashing design. While functional, this design is more susceptible to damage from foot traffic than contemporary flashing methods, and the age and condition of these flashings indicate that replacement should be considered to extend the serviceable life of the roof.</p> | <p>Replace soaker flashings to electric fan penetrations with a contemporary tray flashing solution. Any associated Dektite boots should be replaced concurrently, or the relevant penetrations incorporated into the new flashing design. All associated sealant and fixings should be checked and made good in conjunction with this work.</p> | |

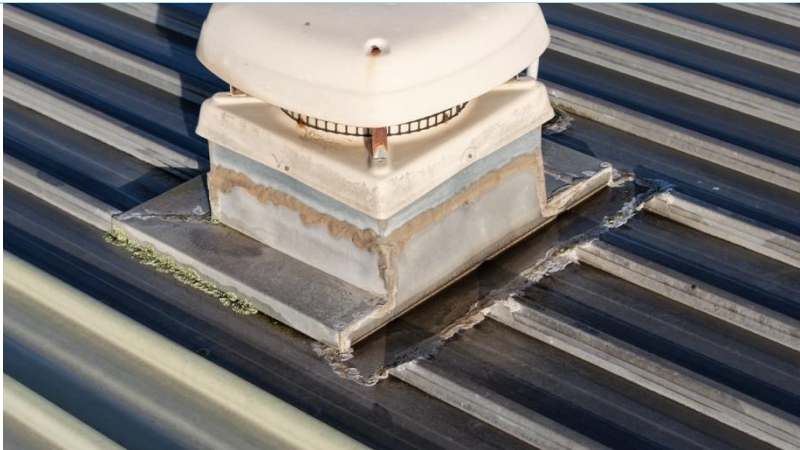
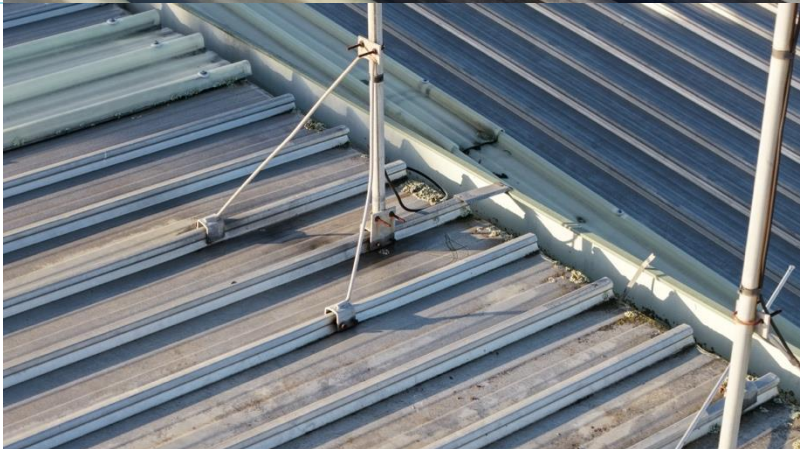
- The communications mast on Roof 4 is affixed using hardware exhibiting severe corrosion. Corrosion transfer to the surrounding roof sheet substrate is considered likely and should be investigated and treated without delay to prevent further deterioration.

| 4 | <b>Penetrations</b> | A communications mast is fixed to the roof using hardware which exhibits severe corrosion. This suggests that corrosion may have already transferred to the roof sheet substrate. | Physically inspect mast fixings and surrounding roof sheet substrate for corrosion transfer. Replace all corroded fixing hardware with corrosion resistant alternatives. Treat any affected areas of roof sheet substrate with a corrosion inhibiting primer and compatible coating, and reseal all penetrations on completion. | |

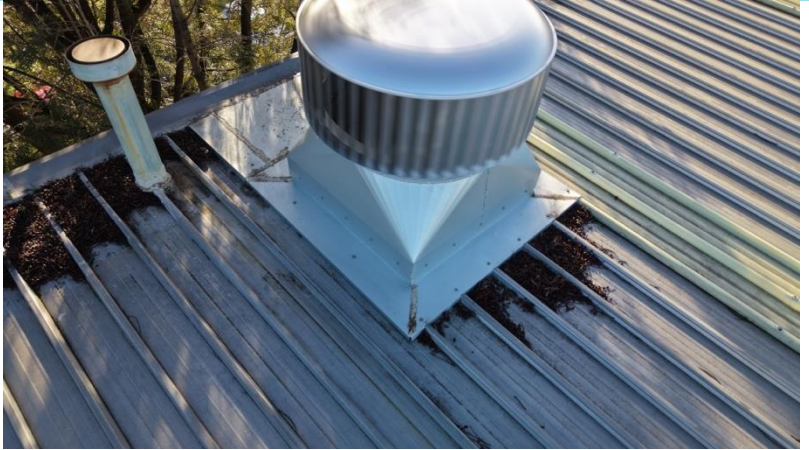
| 5 | <b>Rotary Roof Ventilators</b> | <p>Side flashings to the rotary roof ventilators are of insufficient width to form an effective dry pan. Where a dry pan cannot be achieved at a ventilator penetration, water is not adequately directed clear of the flashing junction, increasing the risk of water ingress at this location.</p> <p>See section 4. Findings Summary: Roof Ventilator Leaks.</p> | <p>Replace or extend side flashings to the rotary roof ventilators to achieve sufficient width to form a compliant dry pan detail. All associated sealant and fixings should be checked and made good in conjunction with this work.</p> | |

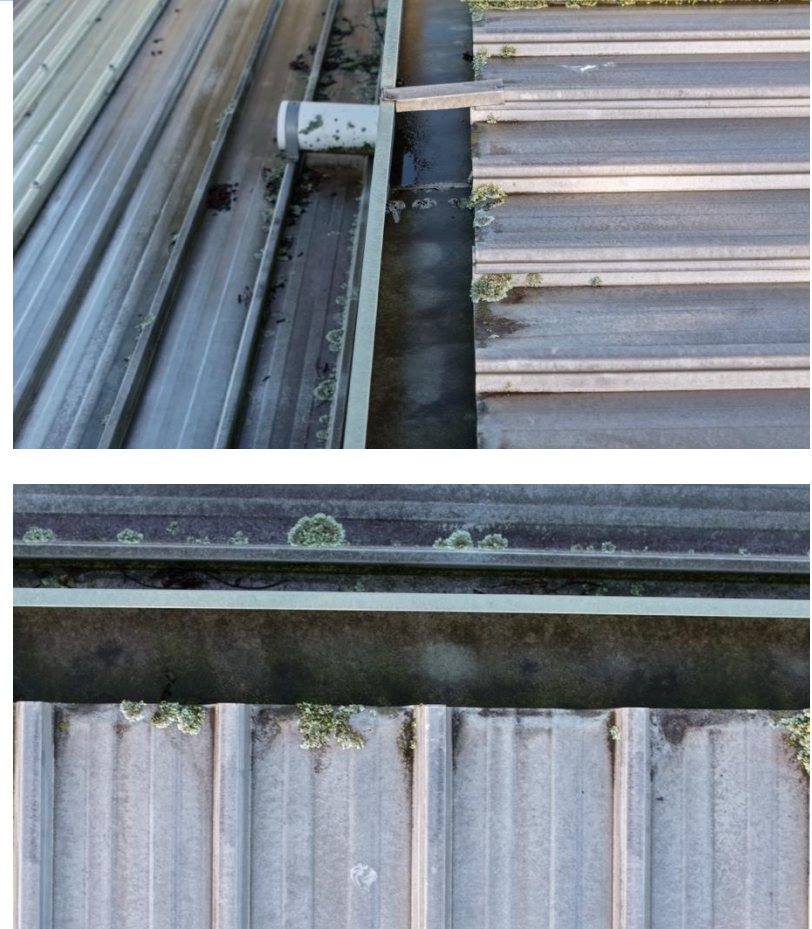
| 6 | <b>Eaves Gutters</b> | <p>Eaves gutters are Colorbond and are in generally good condition. A small amount of sediment and plant debris was observed along the gutter length with no significant accumulation or evidence of ponding. Rust was observed on the interior surface of the gutter at some locations.</p> | <p>Clean gutters and remove all accumulated debris. Following cleaning, treat all areas of visible rust with a corrosion inhibiting primer and compatible coating to arrest further deterioration. Regular scheduled cleaning is recommended to minimise ongoing corrosion risk.</p> | |
