# ROOF INSPECTION REPORT

Date of Inspection: 14 June 2026  
Date of Report Submission: 22 June 2026  
Report No: 26-004-R01-A  
Job No: 26-004

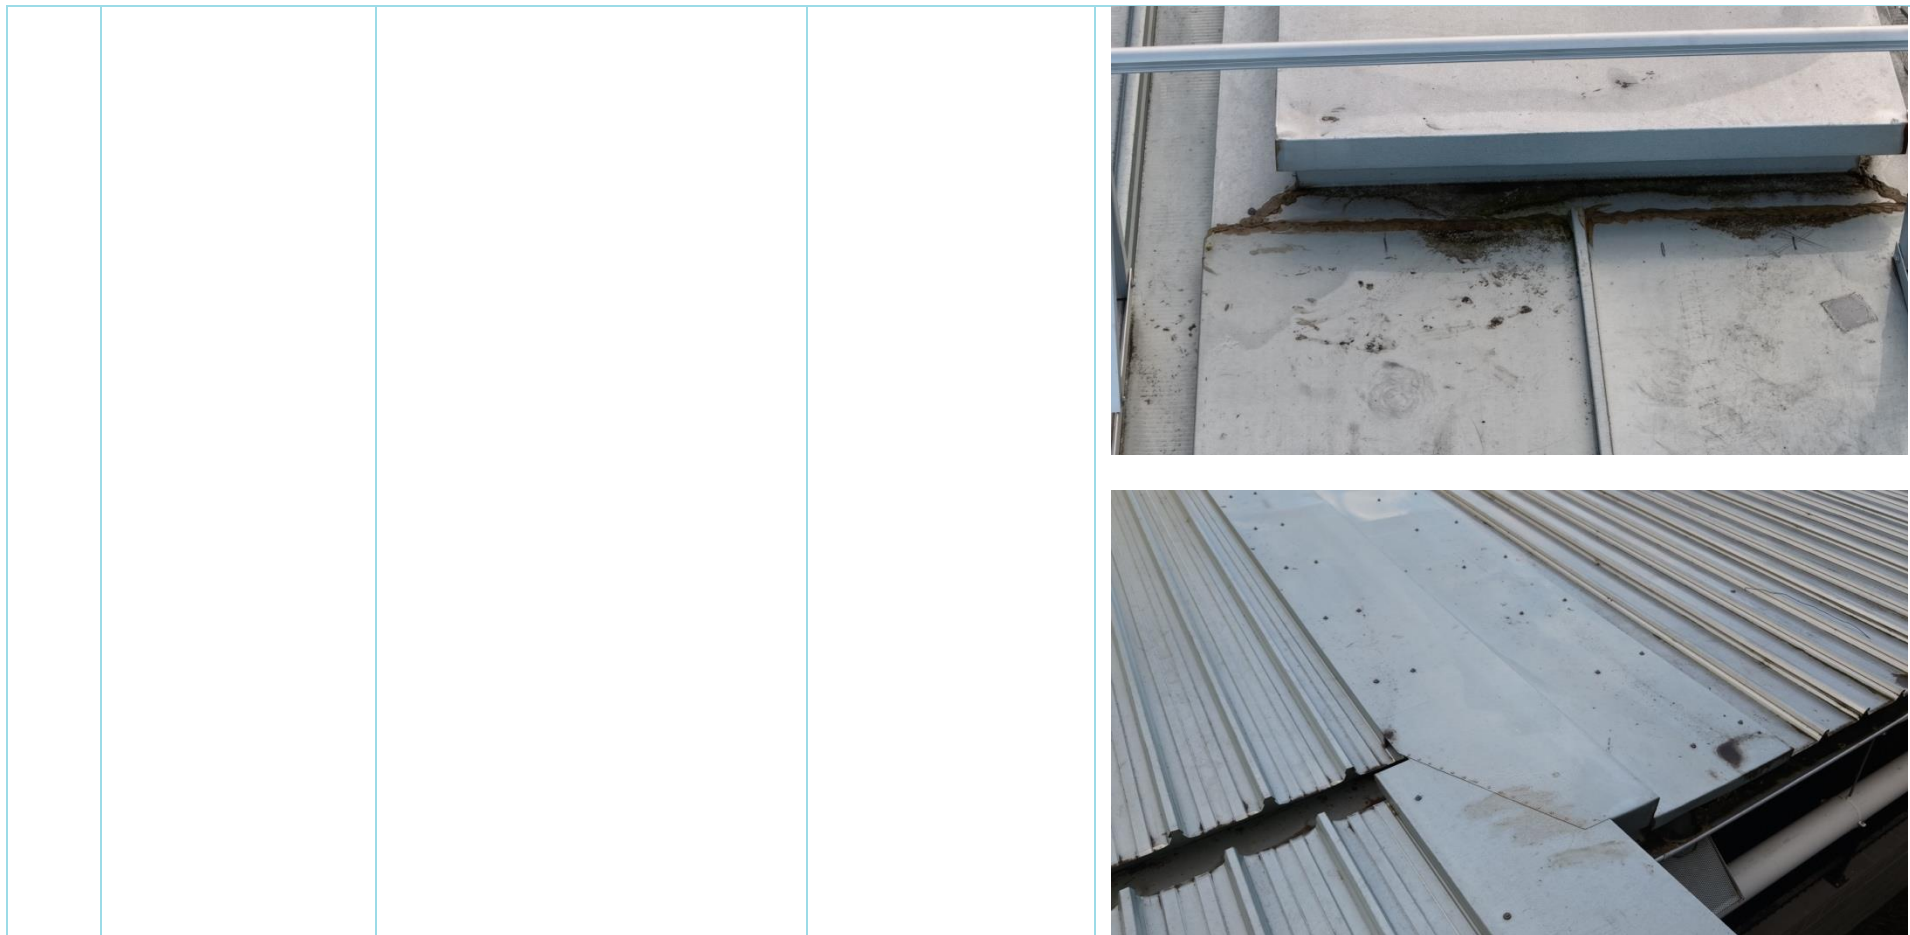
| 2 | <b>Flashings</b> | <p>Flashings have been installed in a generally tradesmanlike manner and are in good visual condition.</p> <p>Apron flashings were observed to be of average scribing quality; however, this is a cosmetic observation only and is not considered likely to affect the weathering performance or service life of the flashing installation.</p> | Generally no action required | |

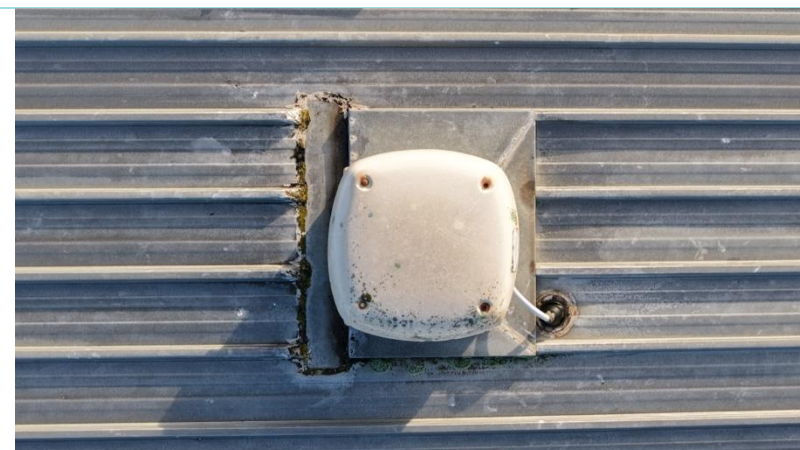
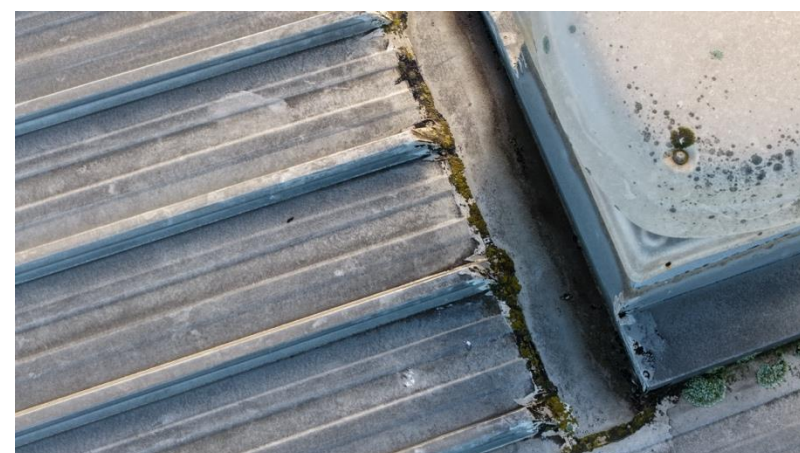
| 4 | <b>Electric Fan Penetrations</b> | Penetration flashings to the electric fans are of a soaker flashing design. While functional, this design is more susceptible to damage from foot traffic than contemporary flashing methods, and the age and condition of these flashings indicate that replacement should be considered to extend the serviceable life of the roof. | Replace soaker flashings to electric fan penetrations with a contemporary tray flashing solution. Any associated Dektite boots should be replaced concurrently, or the relevant penetrations incorporated into the new flashing design. All associated sealant and fixings should be checked and made good in conjunction with this work. |

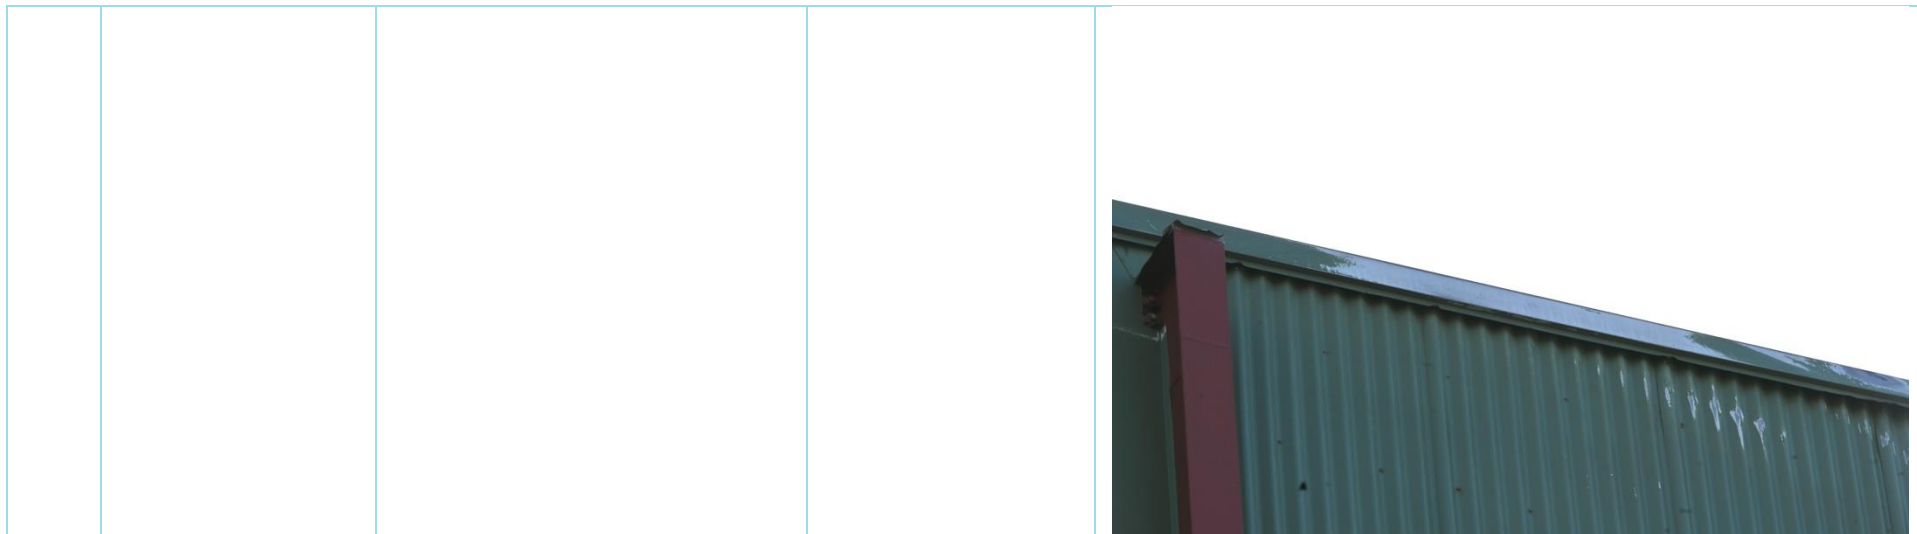
| 7 | <b>Barge Cappings</b> | <p>Barge cappings appear to be in reasonable condition for their age. Undersealing could not be confirmed from the drone inspection undertaken.</p> <p>Areas of abrasive wear were observed where the Colorbond coating has been worn through, exposing the underlying sheet substrate to the elements.</p> | <p>Undertake a physical inspection to confirm the presence and adequacy of undersealing and make good any areas where it is found to be absent or insufficient.</p> <p>Treat all areas of exposed substrate with an appropriate corrosion inhibiting primer and compatible touch-up coating to restore surface protection.</p> | |
